Mechanical Field Review Report #1	
DATE:	August 28, 2019
PAGES:	4
Ref: x19013- Mechanical Field Review Report 20190828	
To:	Business Owner: Bhupinder Bob Sandhu Agra Tandori Restaurant 7366 Marketing Cross Burnaby bob sandhu<bob.sandhu@hotmail.com> 604-626-6472
Cc:	General Contractor and Mechanical contractor Amir Ebadi Nexus Fabrication 604-715-5272 Amir Ebadi<amirnexusfab@gmail.com>
	Fire Suppression Contractor Grease ducks Alex Collins acollins@greaseducks.com
	AECOM Electrical Ltd. Electrician Hardev Singh Cheema 604-363-1554
Project: Agra Tandori Restaurant -Tenant Improvement	
Address:7366 Marketing Cross, Burnaby, BC	
Project No.: x19013	
BP No:	
SUBJECT: Mechanical / Plumbing System Field Review #1 and #2	
Time and Date of Visit-the 3 rd site visit: 2:20 pm. August 28, 2019	Weather: Sunny
VISITED BY: Xiangyang Tan, P.Eng TEL. 778.706.5858	
IN ATTENDANCE: Bob Sandhu, Amir Ebadi, Alex Collins

Mechanical / Plumbing System Field Review Report #1

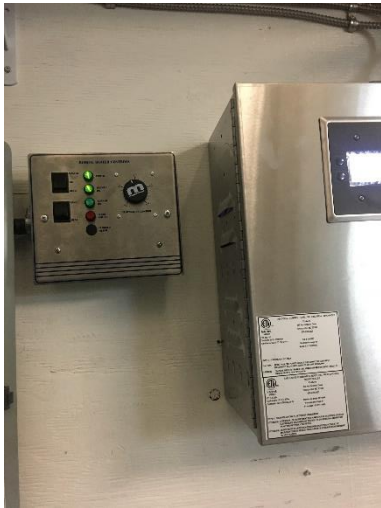
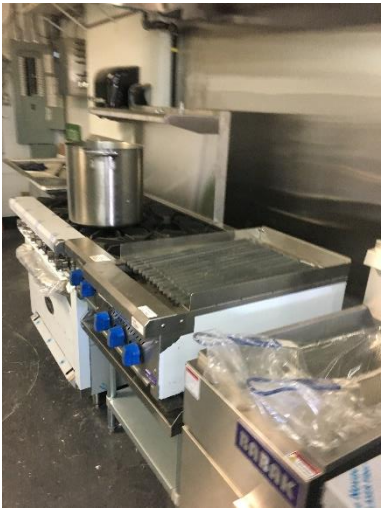
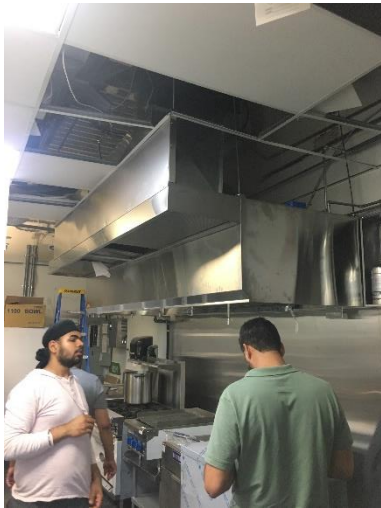
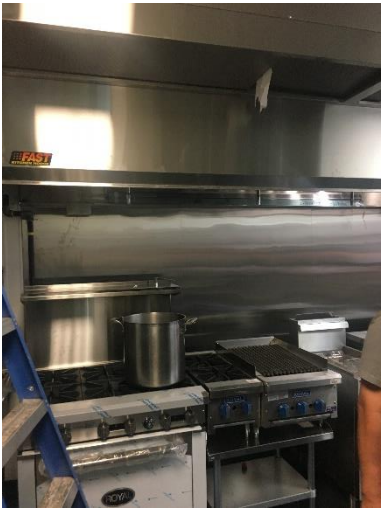
Item	Description	Action
1.1	<p>HVAC Progress:</p> <ol style="list-style-type: none"> 1) New kitchen ventilation system ductwork installation is completed 2) Hood is installed. Fast Kitchen ULC listed hood. Integral makeup air canopy. 3) MAU and EF are installed. No access to roof. Will check in next visit. 4) Control panel is installed. <div style="display: flex; flex-wrap: wrap; justify-content: space-around;">
