West Coast Reduction Ltd.

ORDER# 20134325 TS

SERVICE DATE: 10/22/20

THE ONE TWENTY  
8037 120TH STREET, #120  
DELTA BC V4C 6P7  
CANADA

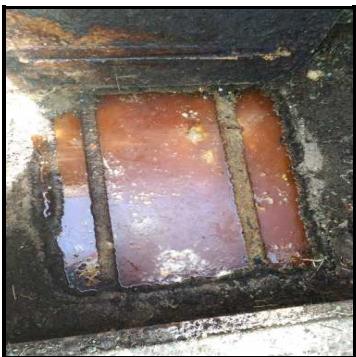
Before Service

Trap ID: TRAP1 Location : BACKDOOR Location Description : OUTSIDE OF KITCHEN BACK DOOR IN GROUND UNDER METAL LID

Bylaw Compliance: No

Repair Details: Flow Plate:Seized,Gasket:Required,Lid:Drill and Tap Required,

Repairs Required: Yes

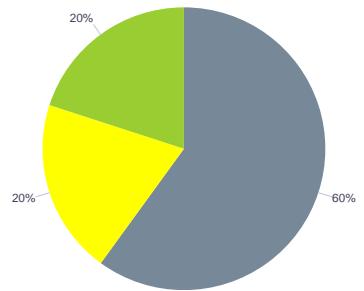
Estimated FOG Analysis

Volume (LT): 380

Frequency: Every 4 Months
