# SERVICE BULLETIN

SUBJECT: ALLANSON /HALTON UV BALLAST.

REFERENCE: DIAGNOSTICS/CONTROL LOGIC FOR UV LAMPS/BALLAST FAULT

**SUBJECT:** HALTON EXHAUST HOODS WITH UV BALLAST BOARDS  
**REFERENCE:** LABELING AND RETURNING BALLAST BOARDS FOR WARRANTY REPLACEMENT PURPOSES  
**EFFECTIVE DATE:** MARCH 2016

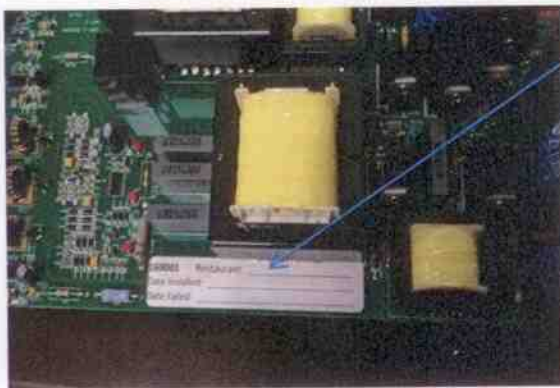
Please follow the steps below when installing or replacing any Allanson UVB664T5-425-P-120 ballast board during commissioning or servicing of Halton UV hoods:

1. Before attaching the accompanying label ( provided by Halton) to the UV ballast board (see photo), fill in the blank label as follows:

**RESTAURANT** (name of kitchen that requires new ballast board installed)  
**DATE INSTALLED** (date the ballast was installed at said kitchen) and, or  
**DATE FAILED** (date the ballast board failed and had to be replaced).

*NOTE: Each ballast board requires a label containing information relevant to that board with the label attached to it.*

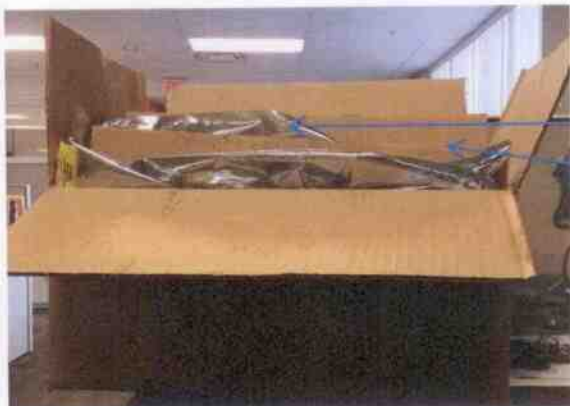
5. When preparing for shipping, please do not stack ballast boards as this will damage delicate components. Ballast boards should be (a) placed in the antistatic bag that came with the replacement board (b) packed upright using either cardboard or sponge for spacing each board.
