X-Radar Concrete Inspection Work Order

1323 Robson St, Vancouver

Grease Ducks Ltd

J170310-05

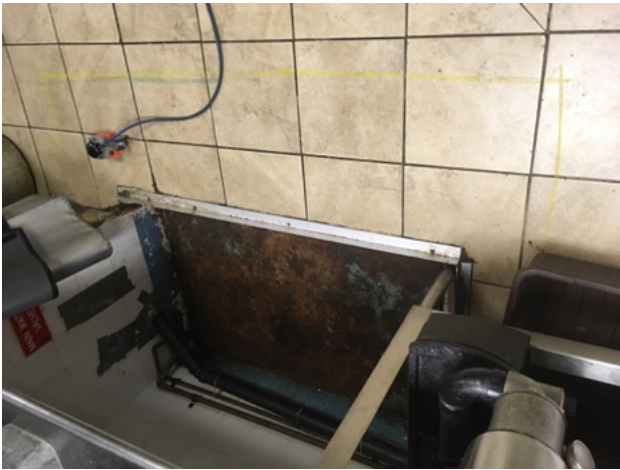
Item	Details
Number of Concrete Slab Types	1
Slab Type 1	
Number of Locations	2
Type of Concrete Slab	Suspended Slab
Type of Suspended Slab	Regular
Slab Thickness	2.5"
Survey Locations	Kitchen
Images of locations	
<div style="display: flex; justify-content: space-around;">

</div>	
Scanned From Both Sides?	No
Location Pin-Pointed to other side?	No
Notes:	
Top Steel Reinforcement (Green) Present?	No
Bottom Steel Reinforcement (Blue) Present?	No
Wire Mesh Present?	Yes
Depth of Wire Mesh?	Varies
Other Items Present in the Slab?	Yes
Other Items:	Metal plate in red
Scan Boundary / Area Unable to be Surveyed Marked? (Yellow)	Yes
Limitations? Check All That Apply	Yes

Item	Details
Unable to scan within 3" of an object?	<input checked="" type="checkbox"/>
Depths Accurate to Within 10-20% (Thickness of the Slab)	<input checked="" type="checkbox"/>
Allow 2" Clearance from identified targets when Cutting, Coring or Drilling	<input checked="" type="checkbox"/>
Notes:	<p>Just a topping on a raised floor ! Steel studs.</p> <p>Be cautious of metal plate.</p>
