Mechanical Field Review Report #1	
DATE:	August 28, 2019
PAGES:	4
Ref: x19013- Mechanical Field Review Report 20190828	
To:	Business Owner: Bhupinder Bob Sandhu Agra Tandori Restaurant 7366 Marketing Cross Burnaby bob sandhu<bob.sandhu@hotmail.com> 604-626-6472
Cc:	General Contractor and Mechanical contractor Amir Ebadi Nexus Fabrication 604-715-5272 Amir Ebadi<amirnexusfab@gmail.com>
	Fire Suppression Contractor Grease ducks Alex Collins acollins@greaseducks.com
	AECOM Electrical Ltd. Electrician Hardev Singh Cheema 604-363-1554
Project: Agra Tandori Restaurant -Tenant Improvement	
Address:7366 Marketing Cross, Burnaby, BC	
Project No.: x19013	
BP No:	
SUBJECT: Mechanical / Plumbing System Field Review #1 and #2	
Time and Date of Visit-the 3 rd site visit: 2:20 pm. August 28, 2019	Weather: Sunny
VISITED BY: Xiangyang Tan, P.Eng TEL. 778.706.5858	
IN ATTENDANCE: Bob Sandhu, Amir Ebadi, Alex Collins

Mechanical / Plumbing System Field Review Report #1

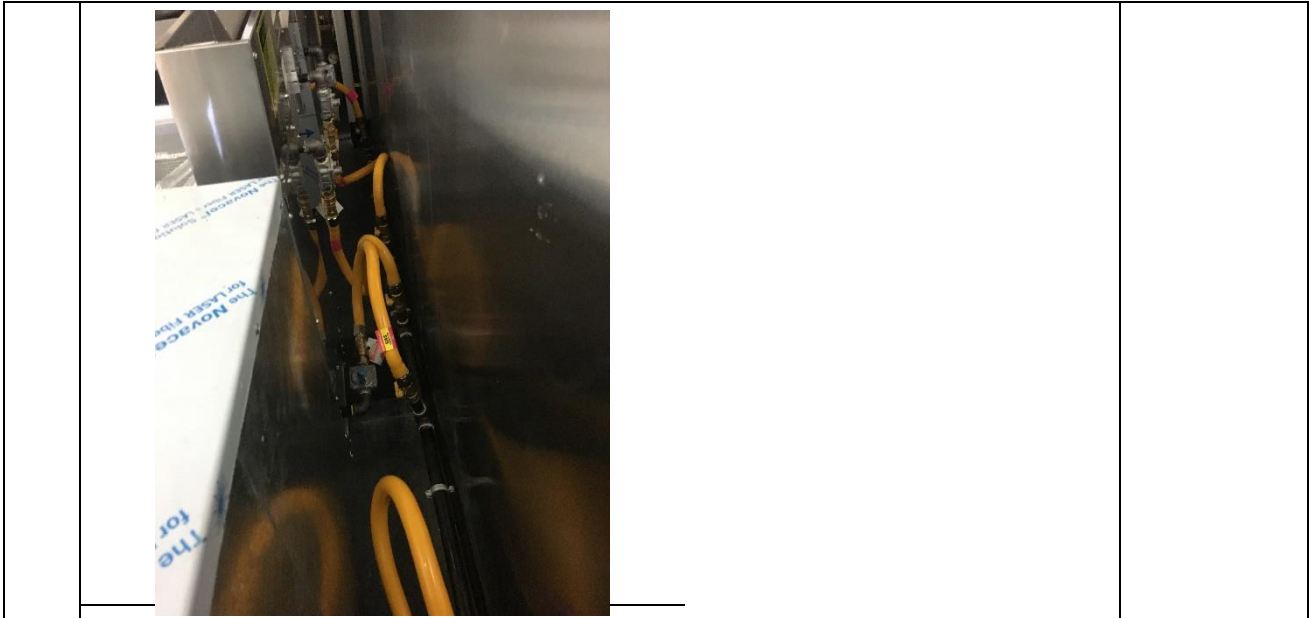
1.3	<p>Tripping test is performed and failed.</p> <ol style="list-style-type: none"> 1) Pipe system is not test. Contractor shall use test pipe system to check if there is any blocktage. 2) Alarm is not activated. 3) Makeup air unit is still on after fire system is trigger. Interlock system is not connected properly. 4) Pull station and trigger system are not tested. <p>Re-test is required. Call engineer 2 days in advance to witness the test.</p>	GC

1.4	<p>Provide anchor on cooking appliance legs to ensure the cooking appliance will not be moved.</p>	
1.5	<p>GC shall submit following document to Engineer and Owner before issuing Schedule CB.</p> <ol style="list-style-type: none"> 1) Structural engineer's Schedule CB. Contractor retained structural engineer shall ensure EF and MAU installation, openings on roof, hood and duct installation meet seismic requirements and existing structure has capacity to carry on the additional load. 2) Warranty letter and O and M manual – Kitchen ventilation system 3) Gas system inspection approval note by City and BC Safety. 4) Shop drawings of EF, MAU and Hood. 	GC
